Thermal Oxidizer Experiences at a Treatment, Storage, and Disposal Facility

Lyle Maxwell, Systech Environmental Corporation

ABSTRACT

Two thermal oxidizer systems were selected and installed to dispose of volatile organic emissions generated by a waste disposal operation. This paper provides a description of each case study.

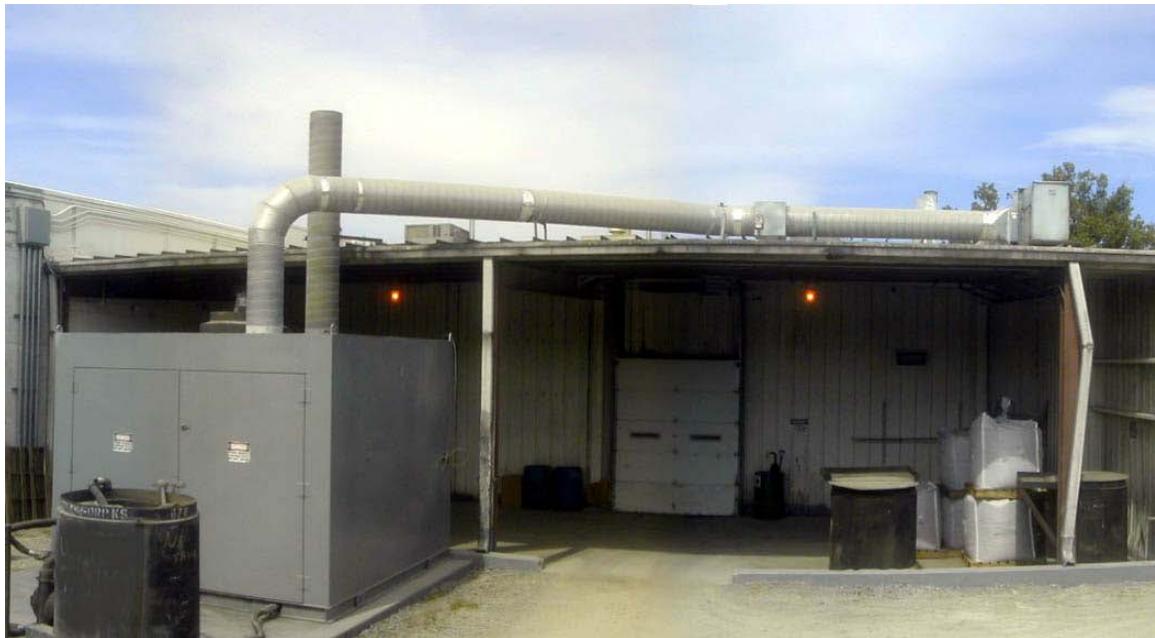
Fig. 1. Systech Container Processing Building vent system – transfer fan on roof feeds activated carbon adsorber at left (grey box with double doors)

After initial testing, drums of waste materials are placed on a conveyor and moved to one of two drain stations, where the contents are removed and further mixed with solvent material. The liquids are pumped to one of several storage tanks. Fumes are released during draining, so a ventilation hood covers each station. The hoods are networked together and connected to a transfer blower located on the roof of the building. In this way, fume exposure in the operating area is limited. Originally, the transfer blower discharge was sent to a nearby Carbon Adsorber where the hydrocarbons were captured and clean air was vented. A granular coal-based activated carbon (Tigg 5C from Tigg Corporation – see reference 1 below) was being used. Periodic testing of the clean air was used to determine when to replace the carbon. Costs for the replacement carbon were averaging about \$7,000 per week.

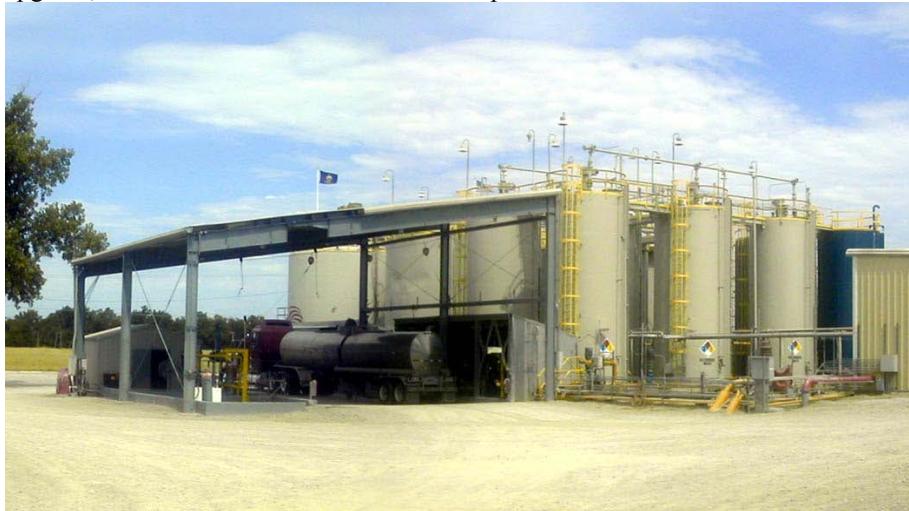
Fig. 2. Tank Truck Unloading and Tank Farm

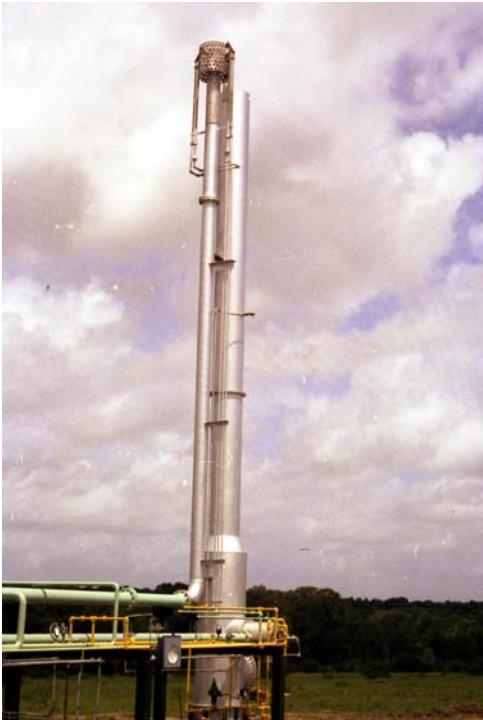
Fig. 3. Elevated Flare supported by an adjacent stack.

Flaring got a more careful look. An elevated flare was rejected because the flame would be visible to the neighbors. Plus, while capital cost for an elevated flare would be relatively low, fuel costs were expected to be high (40 CFR 60.18 requires fuel addition if needed to assure a flare gas heat content of 7.45 MJ/sm³ (200 btu/scf) – a value well above what was expected, on average.)

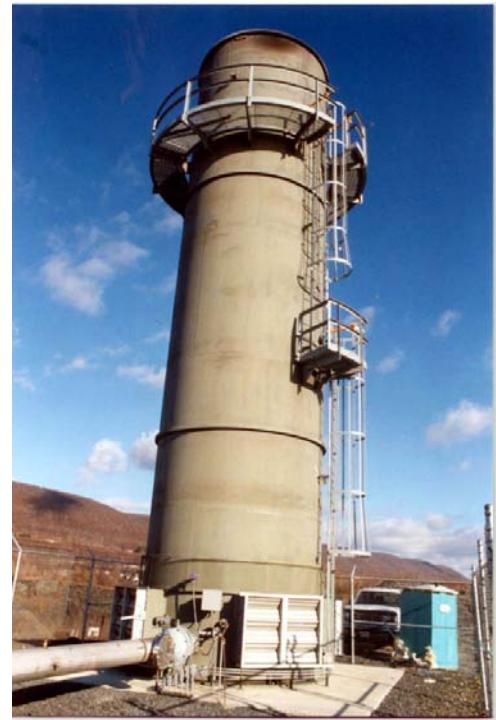
Fig. 4. Typical Enclosed Flare (Courtesy TCE – Ref. 3)

An enclosed flare, instrumented and controlled to operate like a DFTO, would not require a minimum heat content, but maintaining the stack temperature high enough to achieve 95% DRE with the typically low hydrocarbon content from the Container Processing Building would still require excessive fuel gas usage. A flare here would be a bad choice.

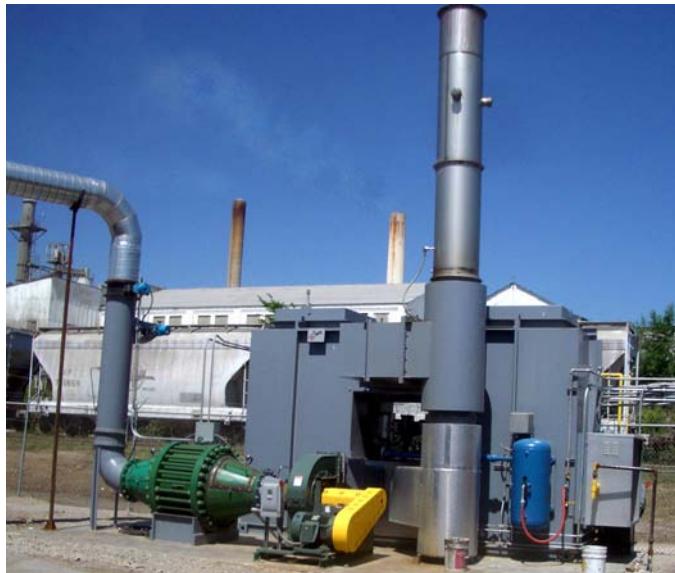
Fig. 7 Systech RTO with waste gas duct from Container Processing Building at left.

The photo above shows the RTO shortly after startup. The waste gas duct enters from the left. The waste gas passes through a motor actuated block damper (just above a motor actuated fresh air entry damper – both actuators blue) and then through a detonation arrestor and into the RTO waste gas fan. The clean gas outlet stack is just to the right of center. The heat exchange packing is located in each of tall rectangular boxes, the waste gas inlet and flue gas plena run across the base of the unit, and the combustion chamber runs across the top of the unit. The primary path for the cooled, treated gas is from the lower plenum to the stack base (covered with aluminum lagging). An alternate path direct from the combustion chamber to the stack (gray painted steel with internal refractory lining) is provided as a “hot gas bypass” when waste gas hydrocarbon content is high. The bypass reduces heat transfer to the packing, resulting in less waste gas preheat and a cooler combustion chamber – useful for avoiding an over-temperature situation when the waste gas is rich.

Installation and startup of the RTO were uneventful. The duct from the collection hood ID fan to the carbon adsorber was replaced with one from the ID fan to the RTO waste gas blower inlet. An Enardo detonation arrestor was positioned a few feet upstream of the RTO waste gas blower. Between the DA and the Container Processing Building was added an automatic isolation damper and an automatic fresh air damper (for RTO operation without the process air stream).

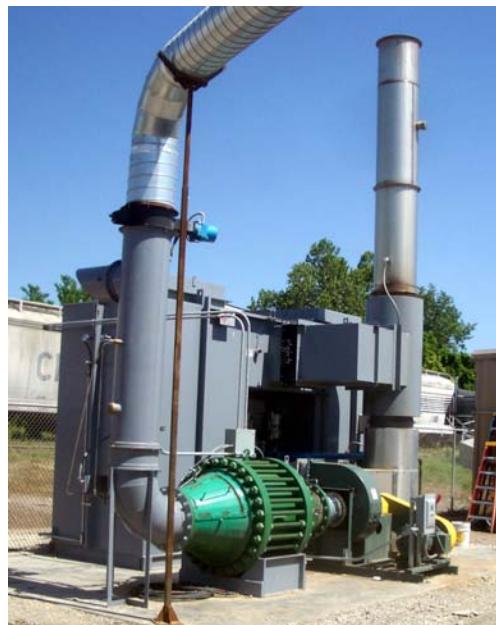
Finally, the operators noted a series of loud noises from the RTO, culminating in an explosion that damaged the flexible boots on the waste gas blower and the waste gas inlet plenum on the RTO. The RTO combustion chamber temperature was approaching the high temperature shutdown level, and the control logic was set to restart the system automatically following any shutdown. During this incident incandescent sparks were observed flying out of one of the vent capture hoods in the Container Processing Building. What caused this effect is still not understood. There were no injuries or damage to other Systech equipment.

Fig. 8. RTO end view.

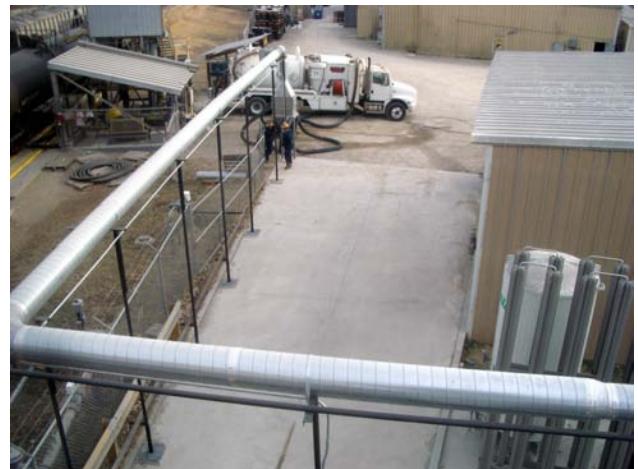
Fig. 10 Vent line "A"

The two vacuum truck discharge vents were ducted separately to the DFTO for treatment. Line A transfers waste air from the tank truck cleaning operation and Line B (shown in photo) transfers waste air from the rail car cleaning operation. The ducts are galvanized steel mounted about 3.7 m (12 ft.) off the ground and sloped away from the DFTO for drainage of any water entrained by the simple scrubber at each vacuum truck. A barometric damper is located between the scrubber and the DFTO, so that if the vacuum truck operator needs to stop operation, air still flows through the duct to the DFTO. A filter box removes any particulate matter before the waste air flows to the DFTO system. The waste air blowers at the DFTO have Variable Frequency Drives. The VFD speed is automatically adjusted to maintain a constant waste air flow based on in-line flow meter readings. Operation is interrupted before the flow is low enough to allow a flashback into the duct.

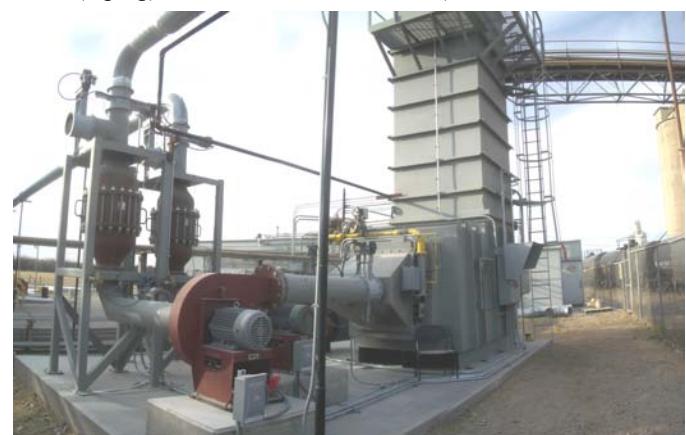
Fig. 11. The DFTO system in operation. Waste air enters the Detonation Arrestors from the top and is transferred to the DFTO burner via the red Process Blowers.

During normal vacuum truck operation, the target furnace temperature is maintained automatically, but on several occasions smoke and even flames have been observed at the stack tip. The operator shuts down the DFTO under this condition.

On two occasions, there has been a flashback in Line A. The DA in that line seems to have functioned well, but a pressure surge in the duct blew the lightweight cover off of the particle filter enclosure, startling the operator. The flashbacks generated enough pressure to deform the Process Blower casing. No other damage and no injuries occurred.

Upon review of the incident, it appears that the hydrocarbon content of the waste air became high enough to over power the cooling air blower. With smoke and fire at the stack tip, it is likely that the furnace was operating under starved-air conditions. No easy explanation for the two flashbacks was discovered. The DFTO was designed to operate with the waste air in the flammable range, but the waste air velocity entering the burner should have been enough to prevent a flame from reaching the Process Blower or DA.

Systech made several changes to prevent further problems with DFTO operation. These included monitoring the hydrocarbon content of the waste air streams, monitoring the DFTO stack oxygen content and adding rupture disks in the waste air transfer lines.

1. An LFL monitor was installed on each waste air duct. These are used to signal any abrupt rise in hydrocarbon content of the stream and serve as an early warning of potential problems to the operator, as well as process control for the DFTO. LFL monitors were selected rather than calorimeters due to the trouble-free operation of the LFL monitors at the Container Processing Building, as well as the slow response time for the calorimeters investigated.
2. A rupture disk with an elevated discharge "snorkel" was installed between the Process Blower and the DA on each waste air duct. This is intended to minimize any pressure surge in the waste air duct, should a flashback occur again.

High readings from the LFL monitor result in closure of the waste air block damper and opening of the fresh air damper to allow the DFTO to continue operation in idle mode. Once the waste air LFL signal returns to an acceptable level, the control system resumes flow of waste air to the DFTO.
